# THE MUSEUM OF MODERN ART

**TITLE:** *Summer Night*

**ARTIST:** Augusto Giacometti

**PURPOSE OF TREATMENT:** This treatment was carried out in preparation for a loan to Switzerland. Treatment was limited to two days and prioritized stabilization.

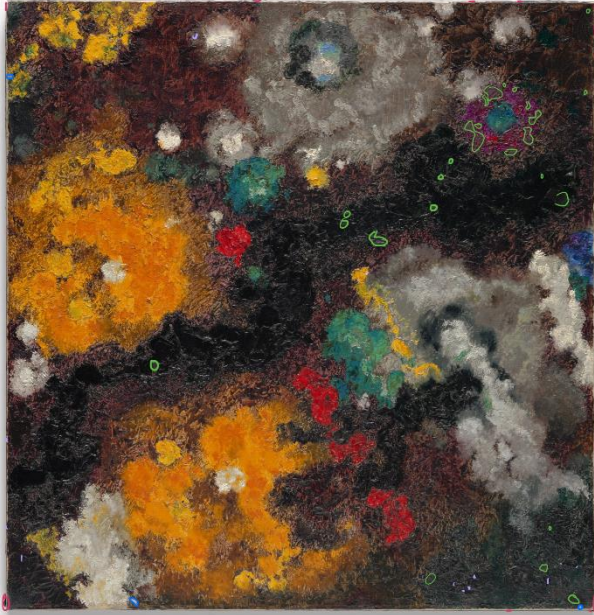
### Condition Map

The paint has an extensive craquelure pattern, portions of which are unstable. The dark teal/black paint most extensively contains points of interlayer cleavage between the paint and ground layers. Past condition reports have noted the greatest instability in the orange and yellow areas. However, these treatments appear to have effectively stabilized these passages, as little to no lifting of unstable cracks were observed.

Finally, there are three losses: the two largest of which are on the lower edge and extend to the ground, and one on the upper left edge where the raw canvas is exposed and has begun to fray (see condition map and detail images below).

■ LOSSES      ■ LIFTING/FRAGILE CRACKS  
■ MATTE SURFACE      ■ LIFTING TAPE

- 1) Fragile and lifting cracks were consolidated with Lascaux medium for consolidation.
- 2) The verso was cleaned with a nylon brush and cosmetic sponges.
- 3) The three losses (two on the lower edge and one on the upper left edge) were filled with modostuc and inpainted with Qor colors. Aquazol 200 15% in DI water was added to the Qor colors to increase the gloss and match the surrounding paint surface.
- 4) Lifting masking tape from the tacking margin was set down with Lascaux medium for consolidation and a heat spatula.
- 5) Splinters in the stretcher were set down with fish glue.
- 6) A polyester batting insert was adhered to the coroplast backing using Velcro. The backing was re-attached using previous screw holes, but replacing the screws with shorter ones (since the previous ones had caused splinters in the stretcher).

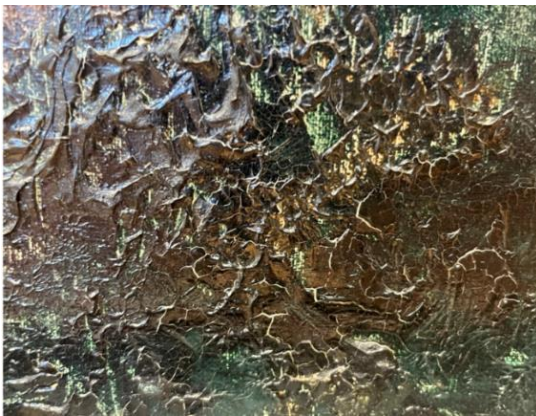
Areas of interlayer cleavage and unstable cracks.

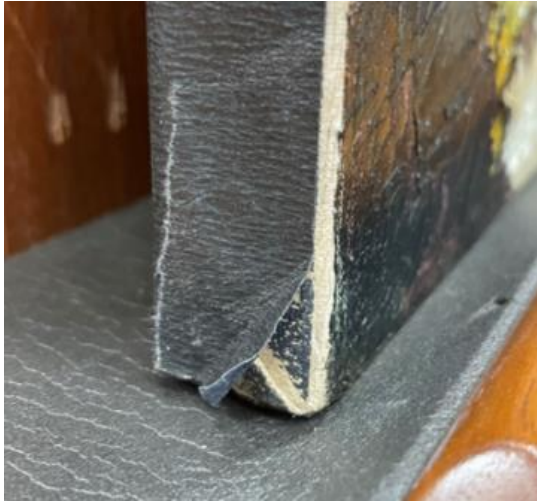
The stretcher has several splinters along the screw holes for the backing board. It is otherwise in good condition. The tape around the tacking margins is lifting at the corners. In these lifted areas, the tape has left behind a thick, sticky black residue, indicating that removing the tape would require solvents. Because of this and time constraints, it was decided to set the tape back in place rather than remove it from all four edges. On the top right tacking edge, there is a bump in the tape from a protruding nail below (see images).

Lifting tape on the tacking margin.

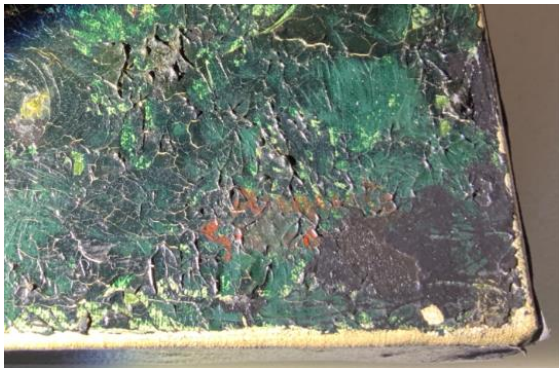
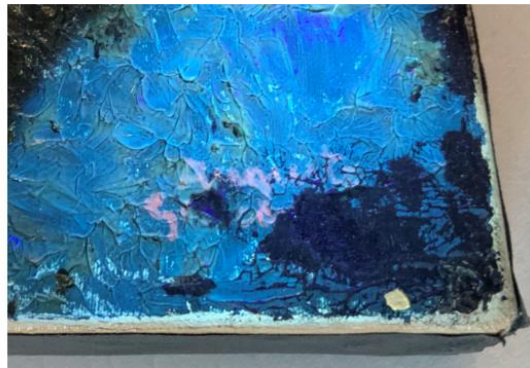
There are matte spots and mismatched inpainting found across the painting. These correspond to areas that appear dark under UV examination (see image below). Some are past repairs that have become matte over time and/or poorly matched in color hue. Others (such as the large matte spots in the purple color) might have been applied by the artist on top of the surface coating.

Artist's signature in the lower, right corner, partially covered by overpaint; loss on lower edge. Left: normal light, right: UV light.

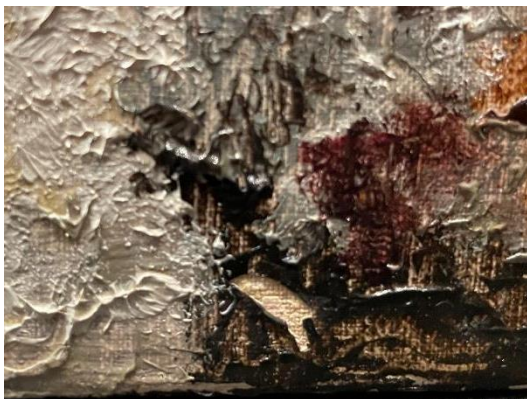
Loss, left side of lower edge.

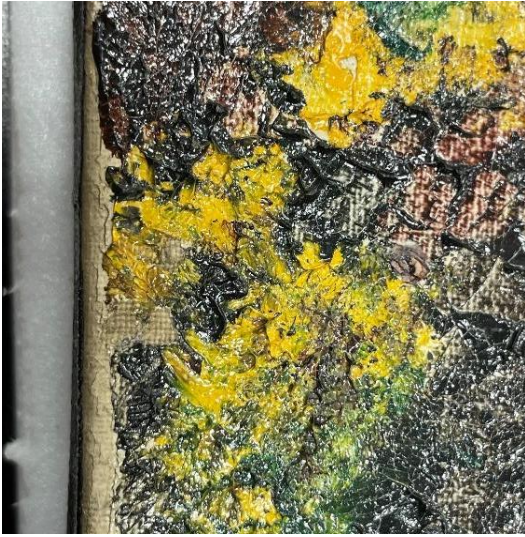
Loss on upper right edge.

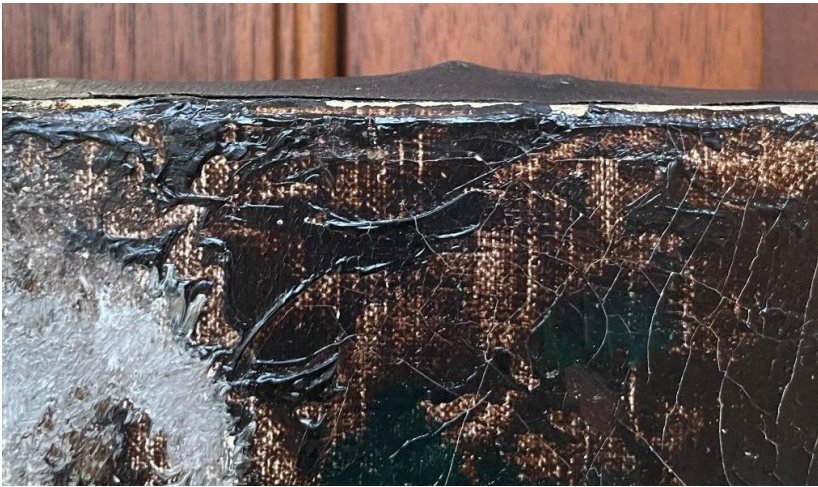
Bump in tape on top right from nail below.
