CONDITION REPORT AND TREATMENT PROPOSAL

**Title:** Painting of Agate Bowl

**Inv. Nr.** GG\_5838

TREATMENT REPORT

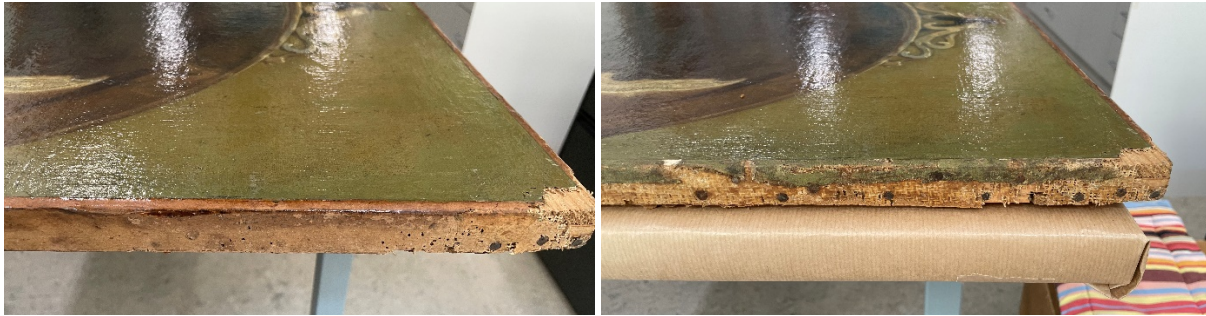
Image 1: Left: Top of proper left tacking edge; a) before removal of paper tape and b) after removal.

The paper tape was removed from with cotton swabs moistened with water and mechanical action (image 1). Ethanol was used to lift varnish from the surface of the tape. Fragile areas along the tacking margins and damaged areas of the painted surface were consolidated with methylcellulose

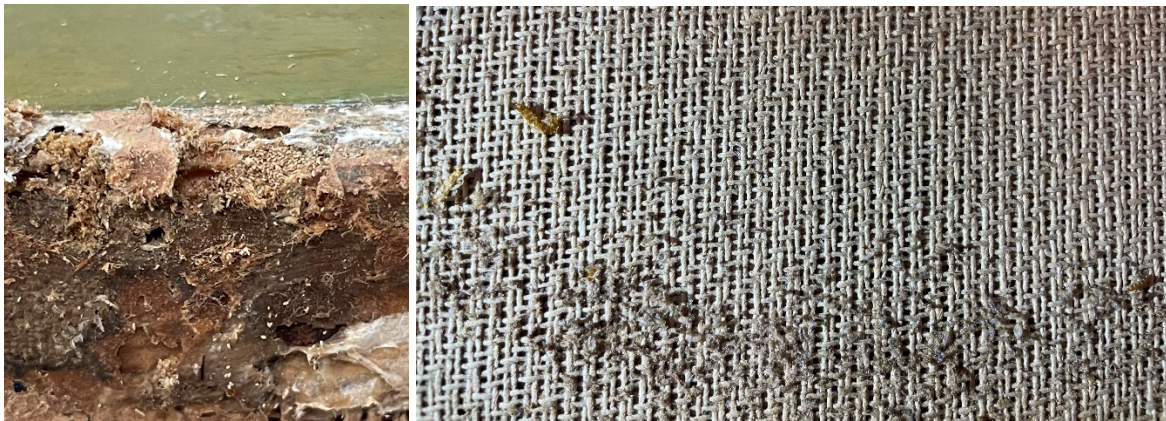
Image 2: Insect droppings and shells on a) the tacking edge between the paper tape and canvas and b) the verso.

The painting was removed from the stretcher. The lining canvas was very stable and, other than the four corners and tacking margin, remained intact. The tacking edge, as well as areas of the verso that had been covered by stretcher bars, had accumulated insect droppings and shells that were cleaned with a vacuum and brush (image 2). X-radiography of a small section of the upper and lower edge of the painting (image 5) revealed that there were small losses to the original canvas, but it remained primarily intact. However, the glue between the lining and original canvas proved to be a thick, hard layer, removed only slowly through mechanical action (as seen in a test on a damaged portion of the top edge, image 6). Additionally, since the insects passed through the open-weave structure of the lining canvas, it remained remarkably stable. As a result, it was determined that removing the lining canvas might leave the original canvas in a more fragile state when returned to storage.

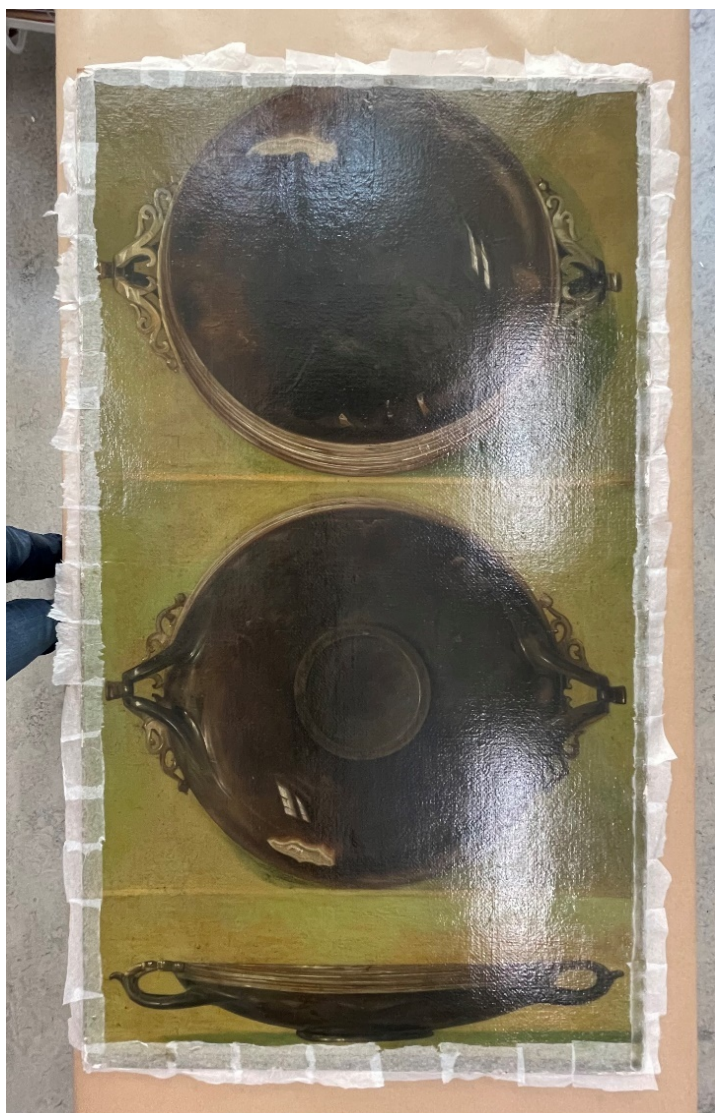
Due to the insect damage, there are small borrowing holes, adjacent cracks, and small losses along the edge of the painting. These are concentrated around the corners and are found at most 4.5 cm from the edge. Around these areas of damage, the paint layer generally appears to have remained stable and in plane.

Image 3: Facing added to the painting edge to protect areas of insect damage.

2.5%. A facing of Japanese tissue was applied with methylcellulose 2.5% to the edge of the painting recto, covering around 4 cm where the insect damage was concentrated (image 3).

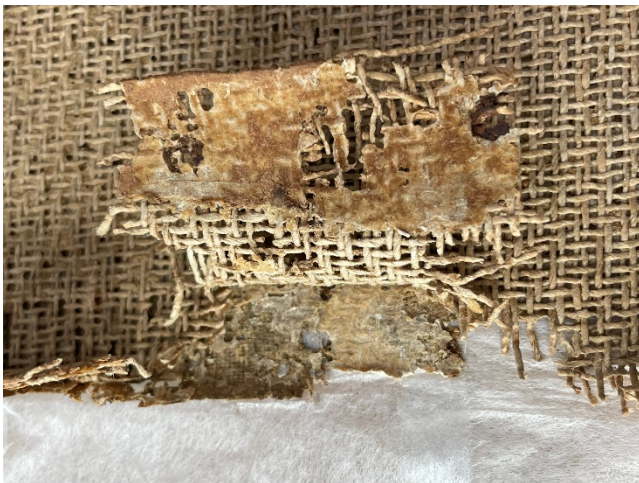
Image 6: Testing removal of lining canvas on a damaged portion of the upper tacking margin. Some of the glue was removed mechanically to the left, revealing the original canvas.

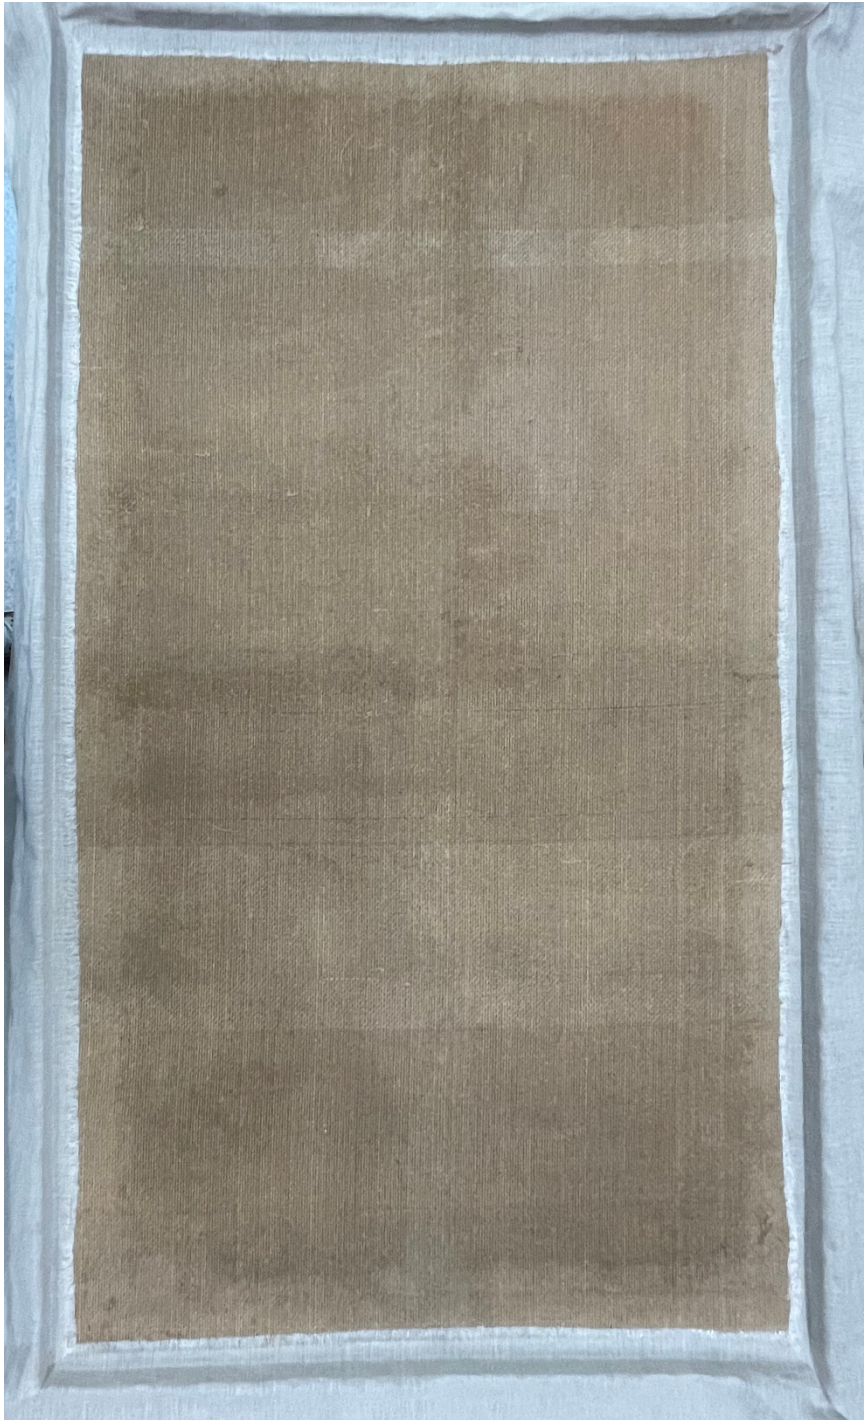
Image 7: Verso with strip lining adhered and before reattaching to the stretcher.

A strip lining of a thin linen fabric was added to reinforce the tacking margins, stretching onto around 3 cm of the verso painting surface, and adhered to the lining canvas (images 7 and 8). BEVA film was applied to both the painting recto and the linen strips, activated using a heated iron spatula.

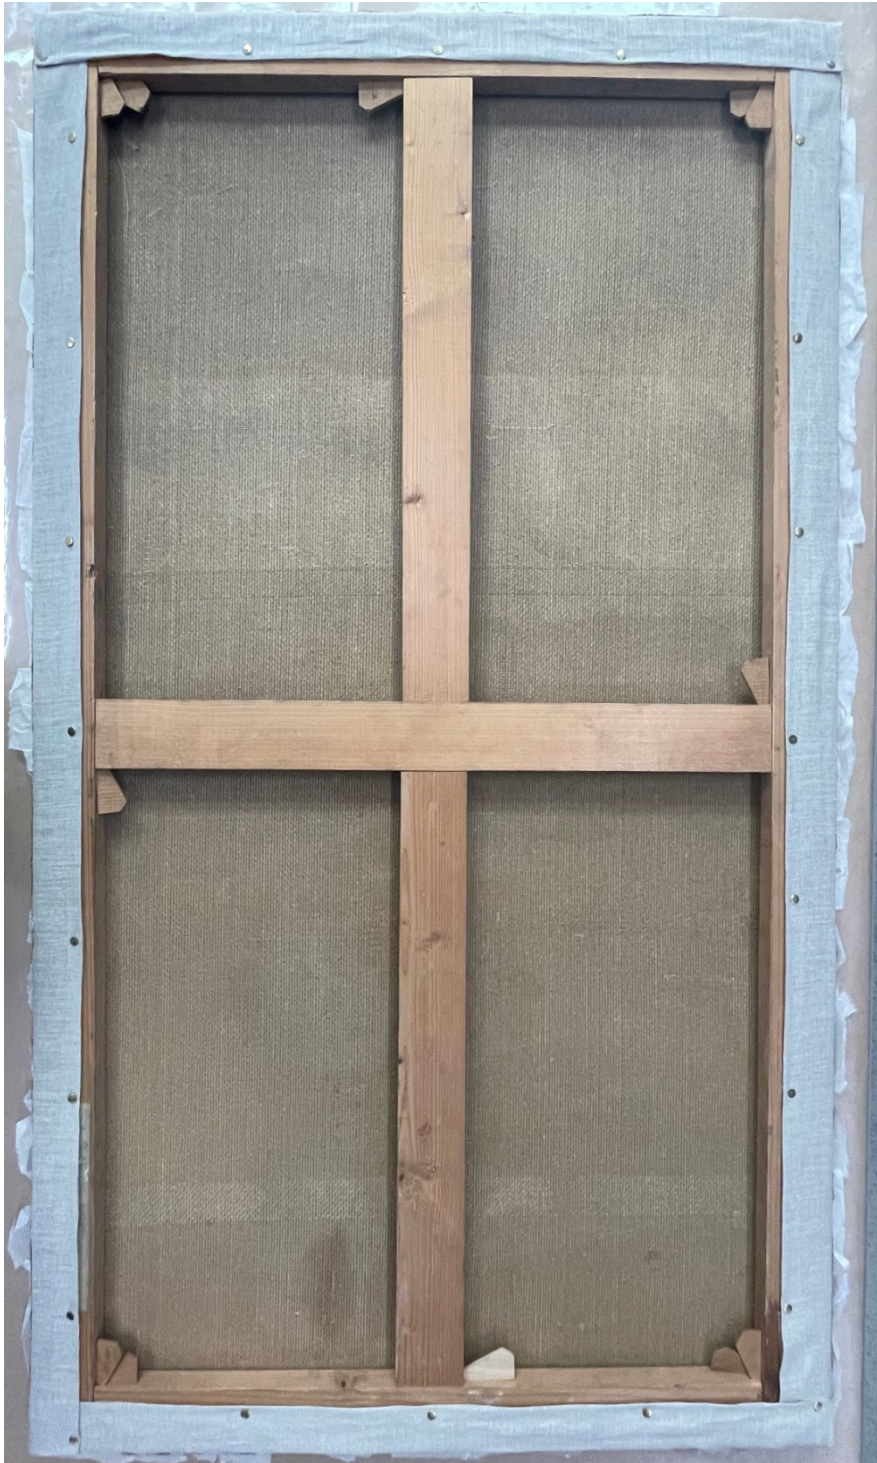
Image 8: Verso following strip lining.

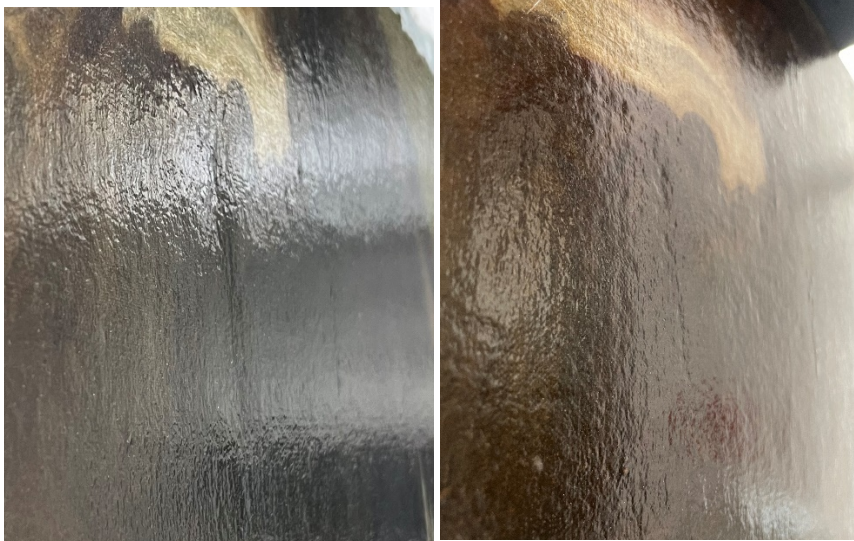
In the upper bowl, there is localized bulging down the top center (around 16 cm), as well as a dent (around 8 cm) in the top left quadrant. These also appear stable.

Image 9: Planar distortion, a) before and b) after moistening and placing under weight.

The surface distortion in the upper bowl was lessened with moistened cloth (layers of hollytex, cotton fabric, and felt), and left under weight overnight. This decreased the region of distortion but did not remove it entirely, likely due to a mass of lining glue between the original and lining canvas concentrated in this area (image 9).

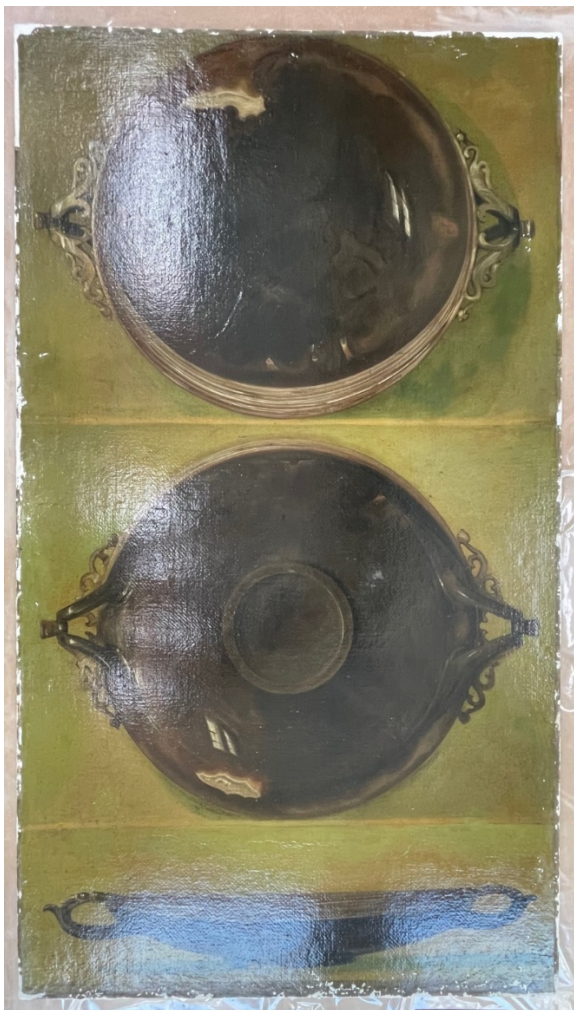
Image 10: Recto with chalk fills.

Canvas fills were added to the large losses in the four corners, adhered with 2.5% methyl cellulose. The losses were filled with a chalk-based fill material (Zecchi Stucco), with linen fibers added for bulk in the deepest losses (for example, image 11).

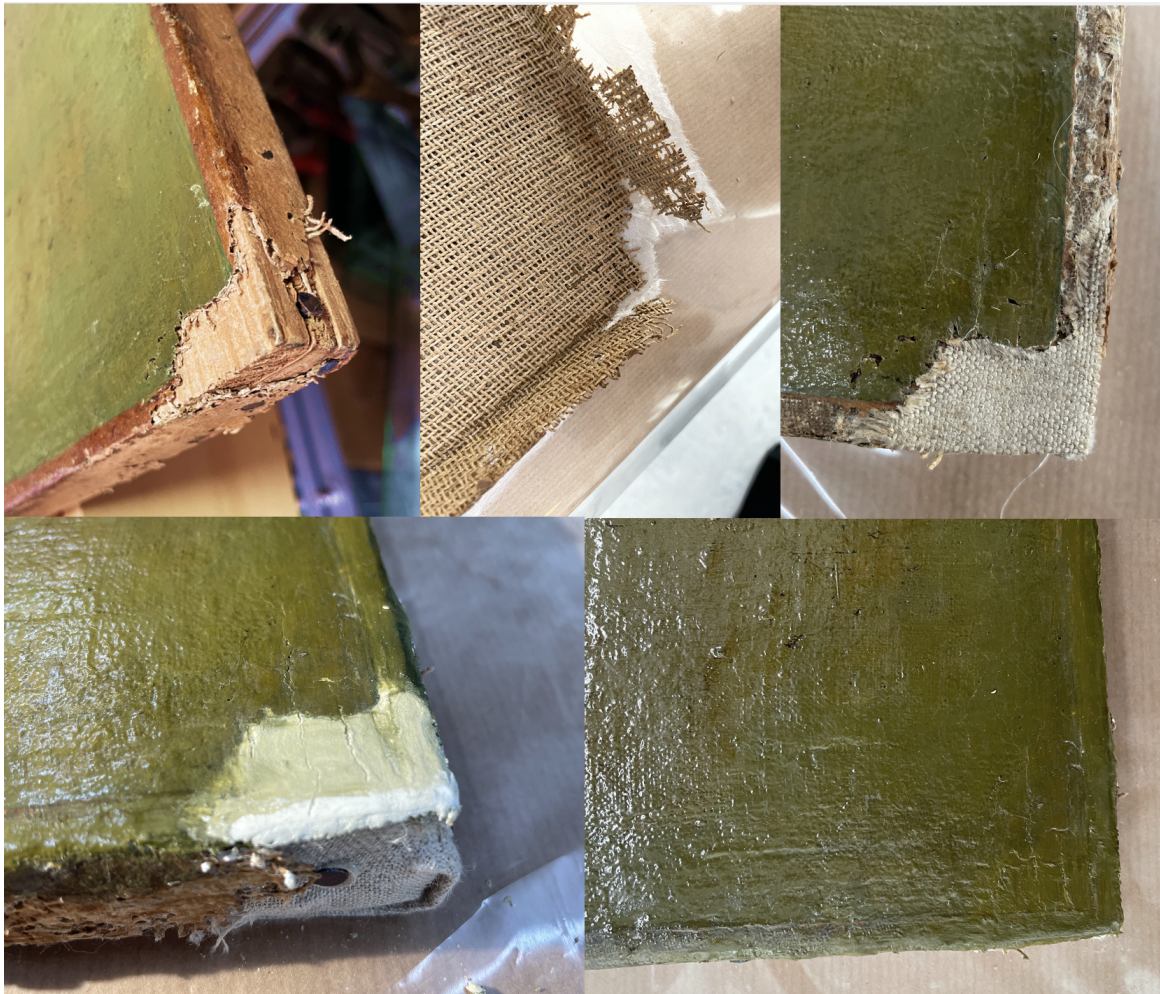
The edges of both the original and lining canvas have been damaged by insects, causing losses in all four corners of up to 9 cm (in the top, right corner).

Image 11: Top left corner, a) before treatment, b) reverse after removing paper tape and stretcher, c) canvas fill in loss, d) chalk-based fill, e) after treatment.

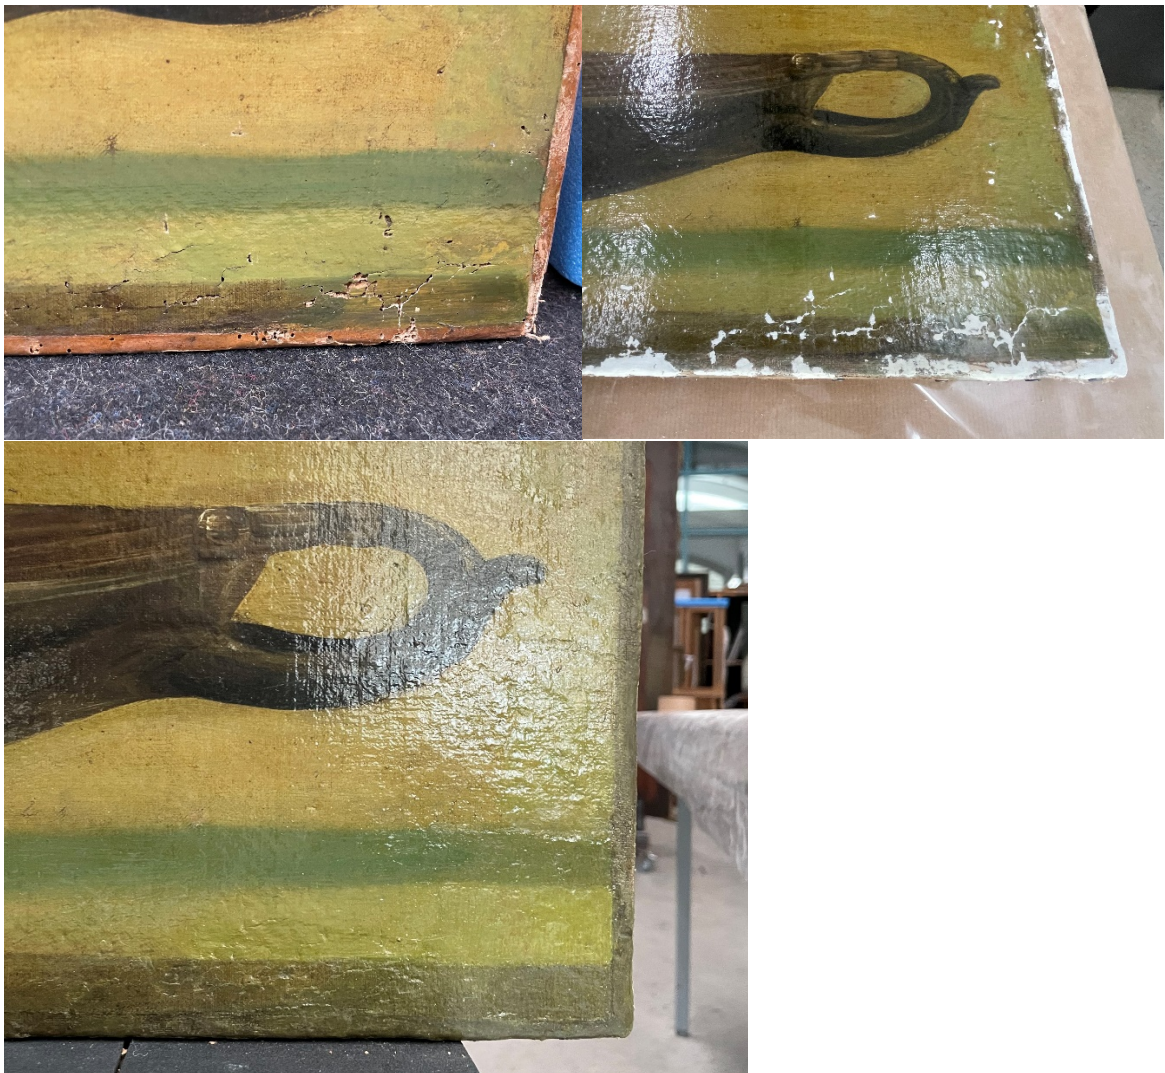
Image 12: Bottom right corner, a) before treatment, b) during treatment, with chalk-based fills, and c) after treatment.

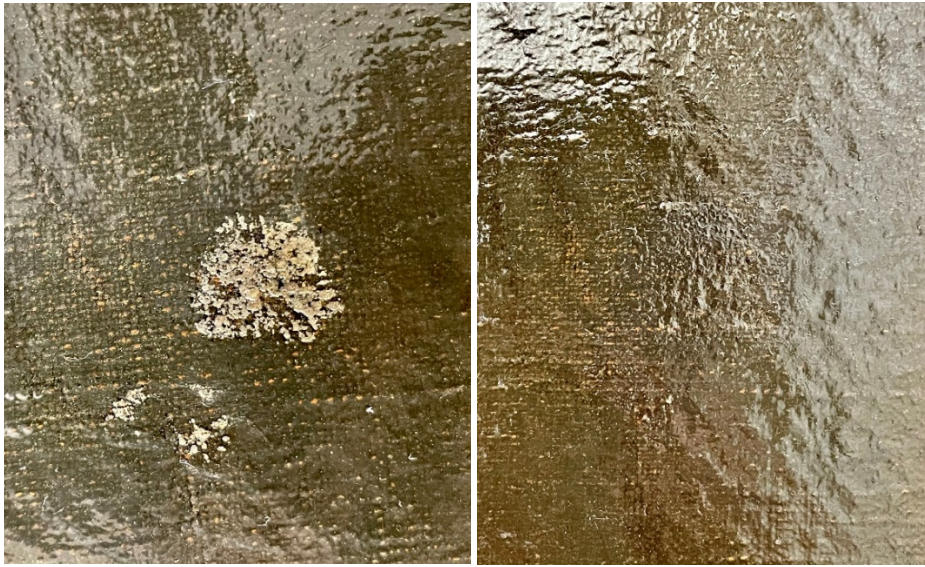
The surface was lightly cleaned with water, which lifted some small points of past inpainting covering accretions (the largest of which was 2 cm, image 13).

Image 13: Abrasion within the central bowl, a) before treatment and b) after treatment.

The losses were inpainted with gouache (Schmincke) followed by watercolor (Schmincke). Areas of past overpaint that were most discolored, as well as small accretions, were lightly toned with watercolor. The largest accretion was shaved down before inpainting (image 13). Abrasions were dotted in with mastic in turpentine (est. 8%), (images 14 and 15). All areas of retouching were also locally varnished with mastic in turpentine (est. 8%).

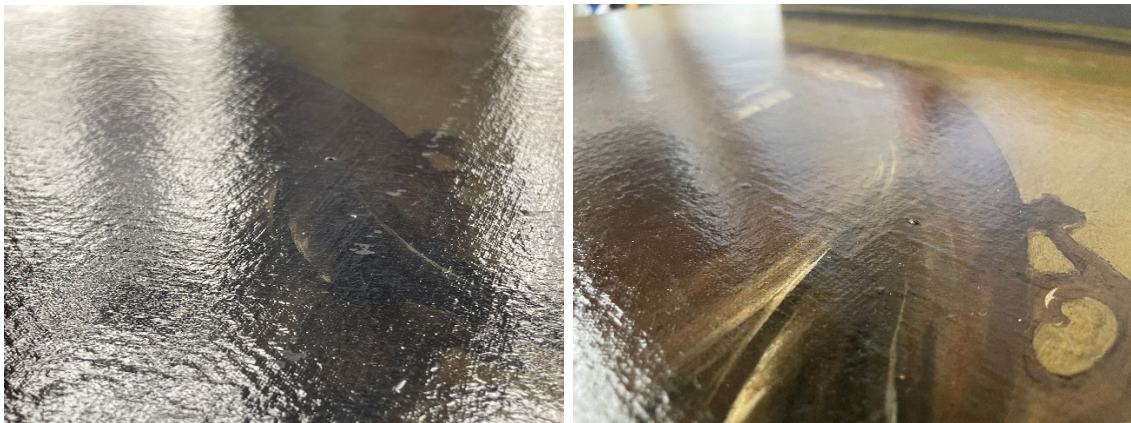
There is a line of matte points of abrasion to the varnish (no more than 0.5 cm each), extending the length of the painting in a line 15 cm from the left edge. These are most visible in the UV photograph. Another large scratch to the varnish passes through the lower, right of the upper bowl and is 25 cm in length.

Image 14: Left edge of central bowl, a) before treatment, showing a line of abraded points, and b) after abrasion was dotted with varnish.

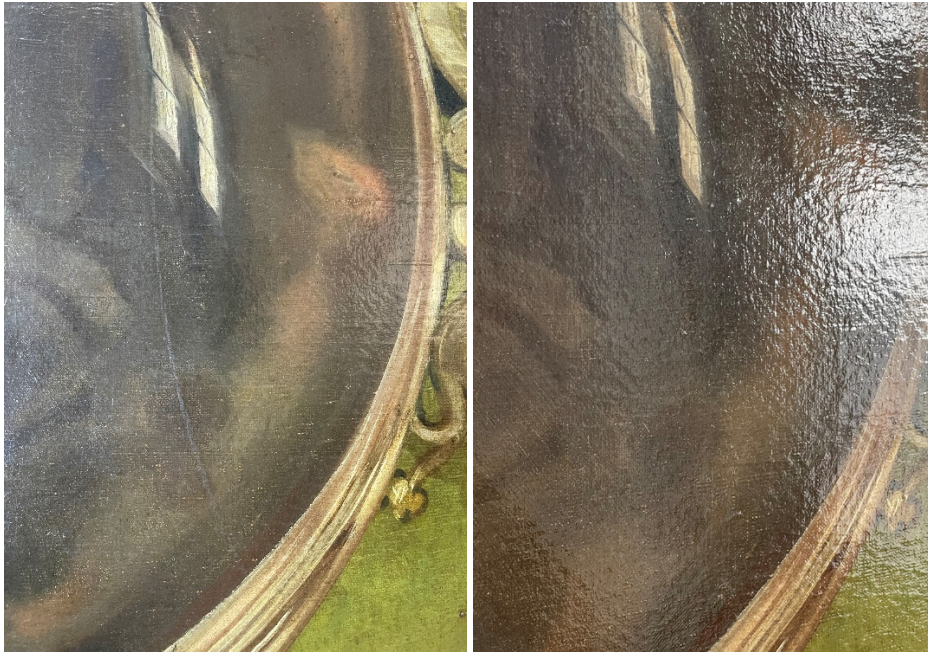
Image 15: Line of abrasion, a) before treatment and b) after dotting with varnish.
