THE CONSERVATION CENTER  
INSTITUTE OF FINE ARTS – NEW YORK UNIVERSITY  
14 East 78th Street  
New York, NY 10075  
TEL: (212) 992-5866 · FAX: (212) 992-5851

## EXAMINATION AND TREATMENT REPORT

**Number:** L220859

**Object Description:** Landscape  
Painting

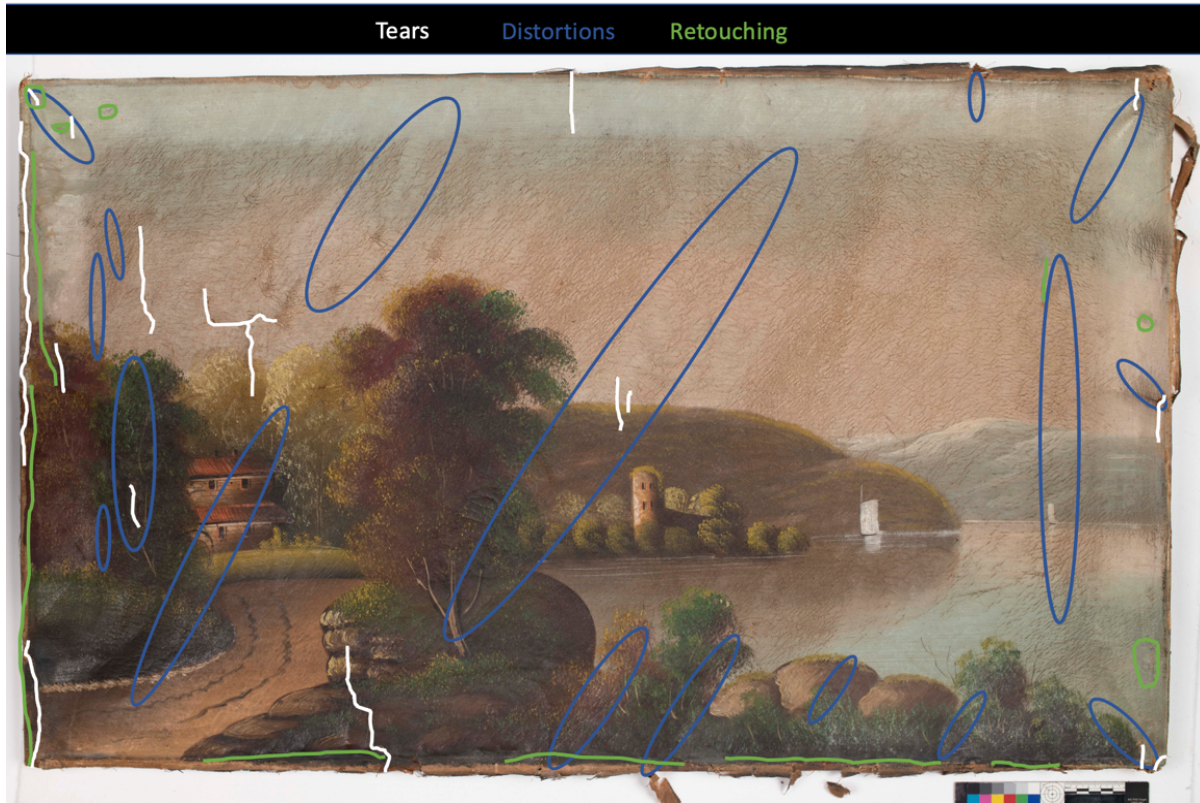
Condition Map

There is an extensive network of stress cracks covering the entire surface of painting and reflecting the canvas weave pattern. The network of cracks significantly decreases over portions supported by the stretcher, and where, as a result, tension on the canvas support has remained more stable. Within this border, the stress cracks increase around points where there are tacks on the turnover edge, especially alongside the right and left edges. Pinpoint losses across the paint film are centered around tears cracks. Additionally, there are four half-circle shapes along the top, proper right edge where the paint layer is noticeably thinner, revealing the canvas below. These likely originated during the original application, since the paint appears to have been smeared while wet, leaving a thin layer with small air bubbles and without significant abrasion. Past retouching is found around the cracks and edges (see condition map). The retouching is

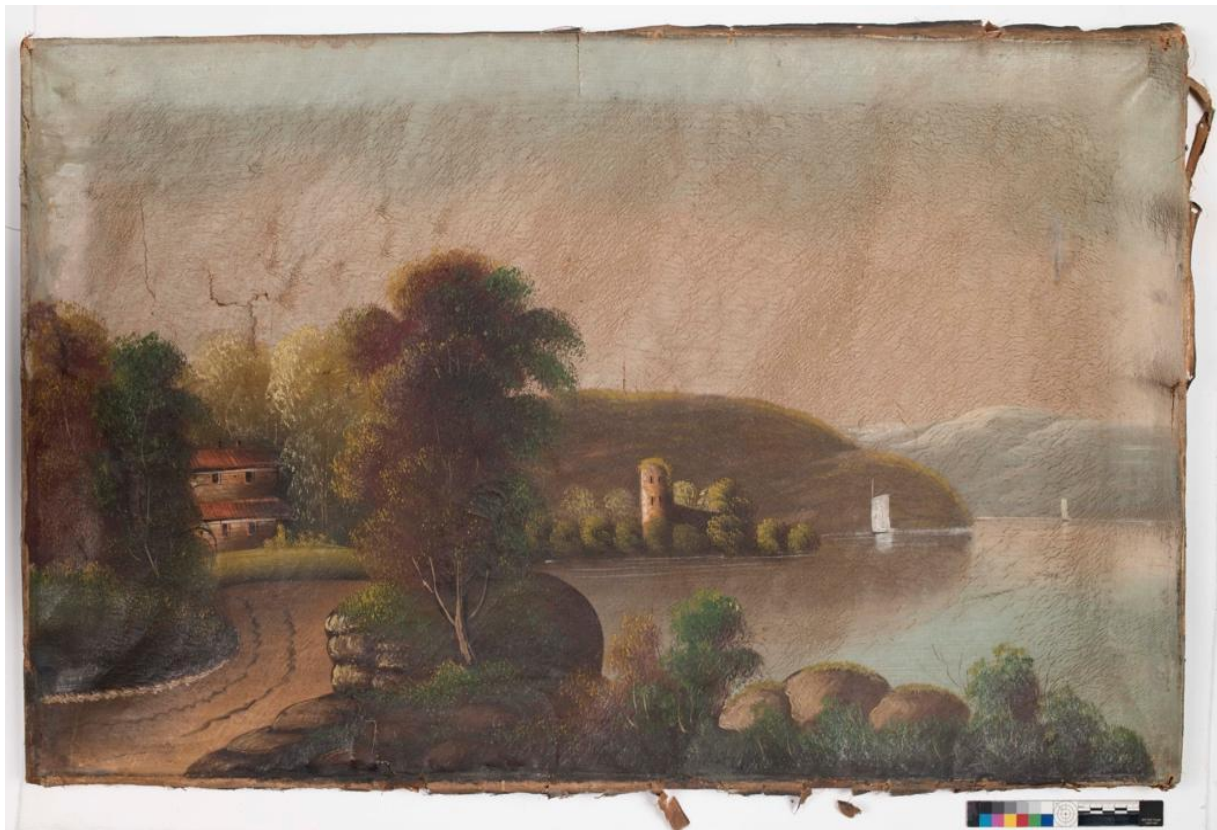
Recto, Normal Light, Before Treatment

The artwork is in poor condition, with extensive planar distortions, stress cracks, and several tears in the canvas. The paint layer has suffered extensive damage due to the failing support, and both the recto and verso are coated in a layer of grime. There has been at least one past conservation effort, which included repairing tears and retouching. No frame is present.

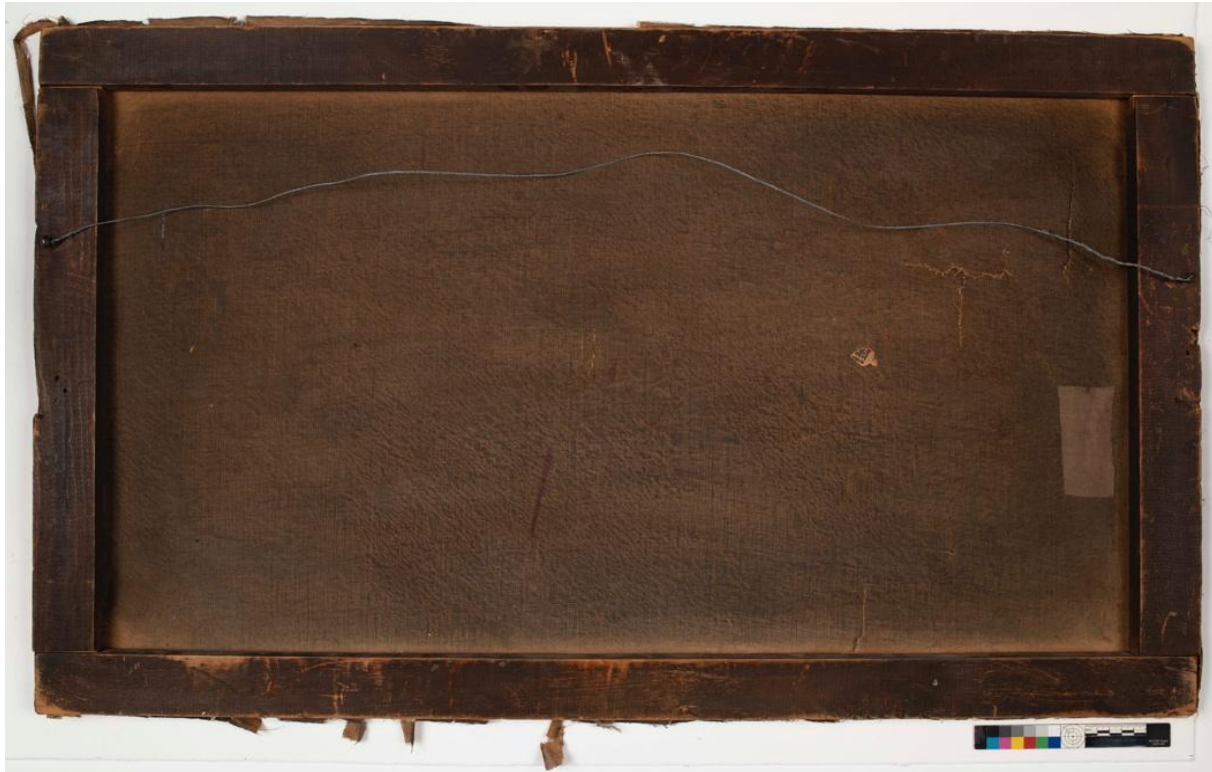
Verso, Normal Light, Before Treatment

The canvas is severely distorted and sagging. There are extensive tears and losses to the turnover edge, preventing the nails from holding the canvas tight. Towards the edge of the canvas, the weave is more open, especially around tacks still holding the canvas in place, supporting the sagging canvas and creating increased stress to the adjacent canvas threads. The recto shows accumulated grime and darkened canvas fabric. There are five large, open tears to the canvas (see condition map): a large T-shaped tear towards the center, proper right; a large complex tear at the bottom, proper right (primarily vertical); and three vertical tears. There are scattered smaller tears, as well as extensive tearing alongside the turnover edge, some of which have been adhered to the stretcher in a past conservation initiative. There is also a canvas patch from a past intervention (around 10x5 cm) addressing a vertical tear on the proper right of the painting, near the center and approximately 6 cm from the edge. Additionally, a tear in the upper, proper left side of the painting has been repaired with a thick adhesive, visible on the verso.

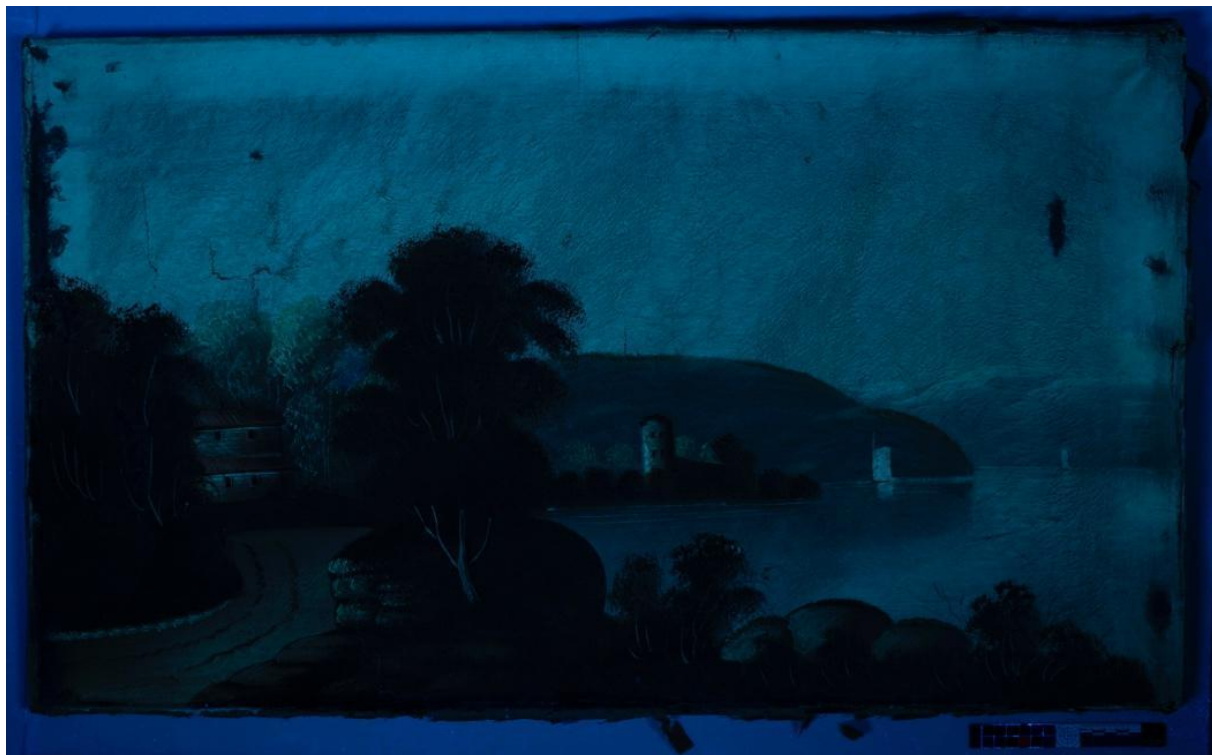
Recto, UV Light, Before Treatment

There is no evidence of a varnish, including under microscopic and UV examination. Leaving the paint layer exposed could have expedited its darkening and wear.

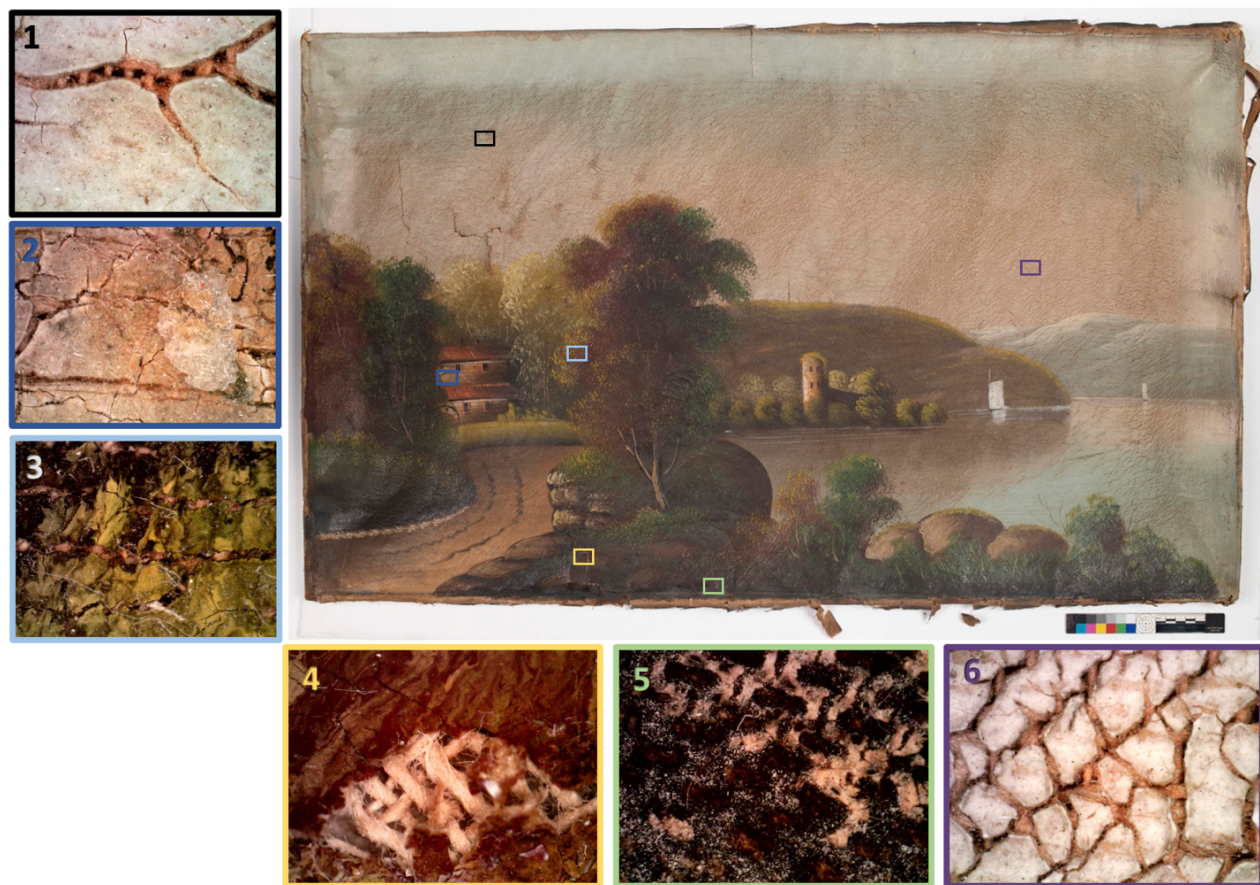
There is no evidence of a ground layer. The canvas appears to be sized with glue, visible as a glossy layer through cracks in the paint layer (see macro photographs in Appendix). The lack of a ground layer likely contributed to the fragility of the paint layer under stress.

Images under 63x magnification using a DinoLite handheld microscope. No ground was observed below the paint layer. There is, however, a thin layer of glue applied to the canvas, seen as a glossy substance through the surface cracks. Additionally, the painting shows no evidence of a varnish on the matte, painted surface. Instead, the glossy flakes seen in image 2 (and observed in the surrounding area) appear to be an adhesive, likely from a past conservation initiative.

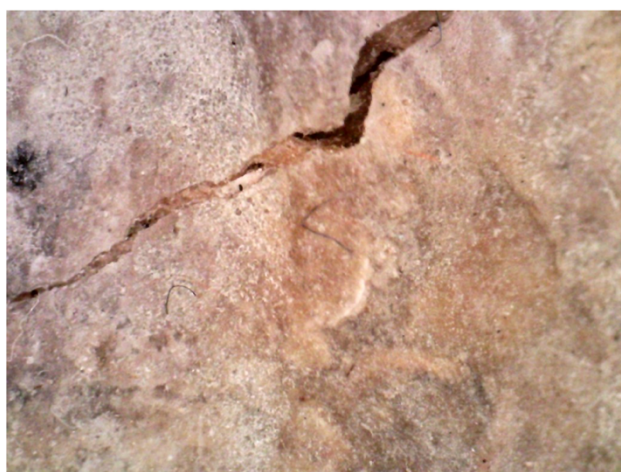
Past retouching

poorly matched, thick, and in portions appears to cover original paint (see macro photography). The paint in the sky shows significant abrasion and darkening.

Border of retouching in the sky (63x magnification, DinoLite), showing how portions cover original paint and the color is poorly matched.
