# THE MUSEUM OF MODERN ART

The David Booth Department of Conservation

**TITLE:** *Twin*

**ARTIST:** Robert Ryman

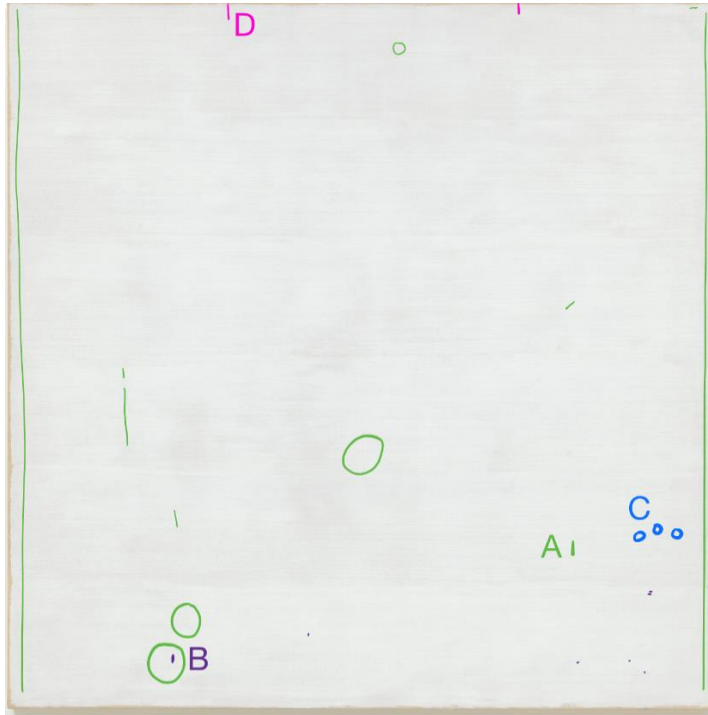
Condition Map:

There are cracks across the ground layer, especially visible under magnification. Some have surfaced and are slightly raised. While stable now, these should be monitored. Travel could also accelerate the formation of surface cracks, something that should be considered before any future loans.

There are three dents in the canvas in the lower right quadrant, around 1 in wide each. There is a small dent on the front edge of the right stretcher, slightly above the center (first noticed 12/13/02). Additionally, there are two thin lines in the paint surface running down a couple of inches from the top edge, and which could be original.

As noted in the damage report, there is a drip in the lower left quadrant, 21 1/2 inches from the left and 13 inches from the bottom. It is around 1 ¼ in long and glossy in appearance. The foreign material appears translucent, but has darkened the appearance of the paint slightly. There are some additional small stains/discolored adhesive near the bottom right edge (see condition map).

\* There are cracks across the ground layer that are beginning to surface, and could be exacerbated by travel
