The David Booth Department of Conservation

TITLE: Naxos

ARTIST: Jack Youngerman

DATE OF EXAMINATION: July 1, 2024

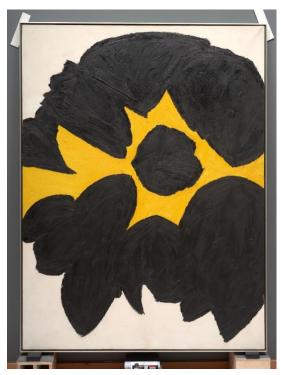
Before Treatment, Recto, Top Light

There are draws in three of the four corners, the largest of which is in the upper right.

The yellow paint has an extensive craquelure pattern. These cracks generally appear stable. There is a small loss in the center left, as well as an area with mismatched retouching near the left edge of the central, black circle (see images below)

On the lowest, right edge of the black paint, there is an ~2 in loss along the turnover edge, as well as unstable, lifting cracks surrounding it.

The white background has extensive retouching, especially along the lower edge in areas of loss. Some areas are yellowed in comparison to the surrounding paint.

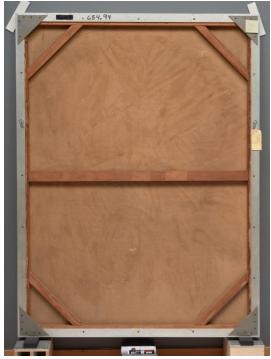
Before Treatment, Verso, Top Light

The screws were loose on three of the four wooden corner braces.

- 1) The verso was dusted with a brush and soot sponges. Accumulated dust and grime were lifted from behind the lower stretcher bar.
- 2) The loose screws on the corner crossbars were tightened.

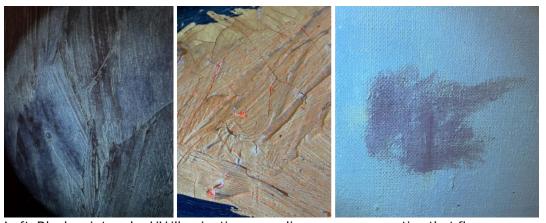
The black and yellow paint is applied with a brushy and thick impasto. In the AQ, Youngerman writes that he used Winsor & Newton ivory black and cadmium yellow. Under ultraviolet analysis, there appears to be two layers of yellow paint, one that remains yellow and the lower layer which fluoresces bright orange (as seen in cracks and losses). This could be two shades of cadmium yellow paint (light and dark, for example). There are small drips of black paint within the lower, white portion of the painting, presumably from applying the black passages above.

There is a layer that fluoresces green over the black paint that is uneven and brushy. Scientific analysis carried out by Abed Haddad and CUNY intern Tomika Benjamin, identifying the coating as an acrylic resin (see FTIR data below and on the O Drive). Given that it is applied selectively to the black paint and in sweeping, uneven strokes, it is assumed this layer was added by Youngerman. Youngerman was aware of the tendency of black paints specifically to develop drying cracks and in other works added medium, such as turpentine, to his black paint (see UKIC presentation on Youngerman's *Black*, *Red*, *and White* on the O Drive by Michael Duffy). He could have added acrylic resin with a similar intention.

Left: Black paint under UV illumination, revealing an uneven coating that fluoresces green-blue Center: Detail of yellow paint under UV illumination. The lower layer that fluoresces bright orange is presumed to be another shade of cadmium yellow.

Right: Area of overpaint in white background near the lower left corner

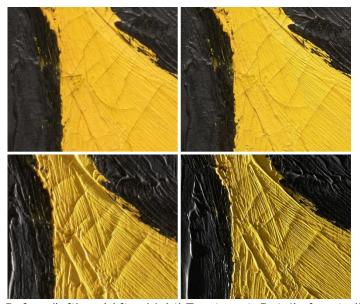
Before (left) and After (right) Treatment: Detail of past, discolored inpainting that was refilled and inpainted, shown in normal and raking light

- 5) Losses were inpainted with Qor color. Losses in the white ground layer around the tacking edges were filled with Modostuc toned with watercolors.
- 6) A coroplast backing board was cut and attached with screws to the verso.

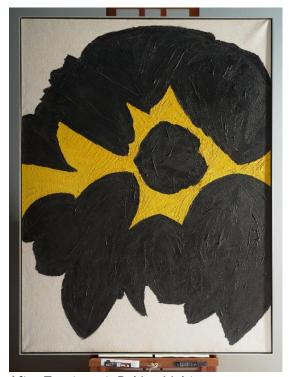
After Treatment, Raking Light

- 4) The draws were flattened by moistening the area with blotter and leaving under weights overnight. Each dent required approximately 3 rounds of flattening. The largest draw in the upper right corner was still faintly visible after treatment, especially in raking light. However, since the stretcher is held in place by the corner braces and metal frame, it was determined that keying it out would be too invasive and that further flattening would merely move the distortion.

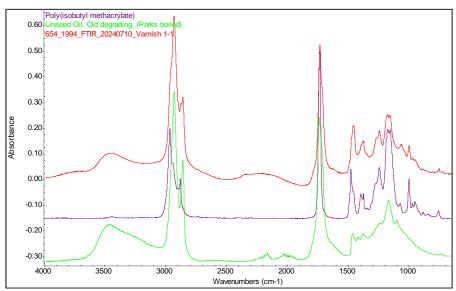
FTIR analysis of the fluorescing coating over the black paint was carried out by Abed Haddad and Tomika Benjamin:

The coating appears to be made of an acrylic resin, which can fluoresce a milky color with age.⁴ Some traces of oil could also be present from the paint medium (especially in the C-H stretch region between 2800-3000 cm⁻¹)
