CONDITION REPORT AND TREATMENT PROPOSAL

**Title:** Painting of Agate Bowl

**Inv. Nr.** GG\_5838

TREATMENT REPORT

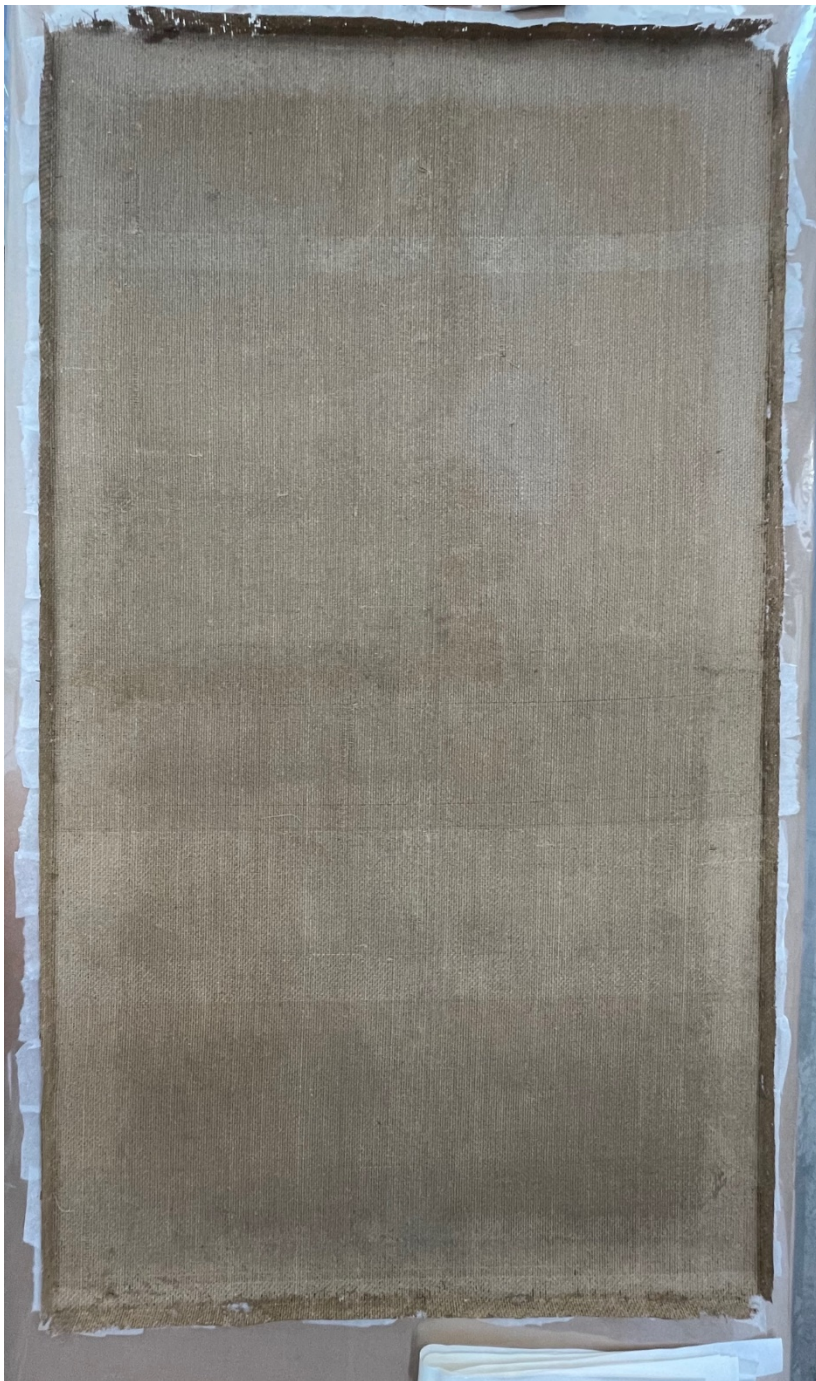
Image 4: Verso after removal of the stretcher.

The painting was removed from the stretcher. The lining canvas was very stable and, other than the four corners and tacking margin, remained intact. The tacking edge, as well as areas of the verso that had been covered by stretcher bars, had accumulated insect droppings and shells that were cleaned with a vacuum and brush (image 2). X-radiography of a small section of the upper and lower edge of the painting (image 5) revealed that there were small losses to the original canvas, but it remained primarily intact. However, the glue between the lining and original canvas proved to be a thick, hard layer, removed only slowly through mechanical action (as seen in a test on a damaged portion of the top edge, image 6). Additionally, since the insects passed through the open-weave structure of the lining canvas, it remained remarkably stable. As a result, it was determined that removing the lining canvas might leave the original canvas in a more fragile state when returned to storage.

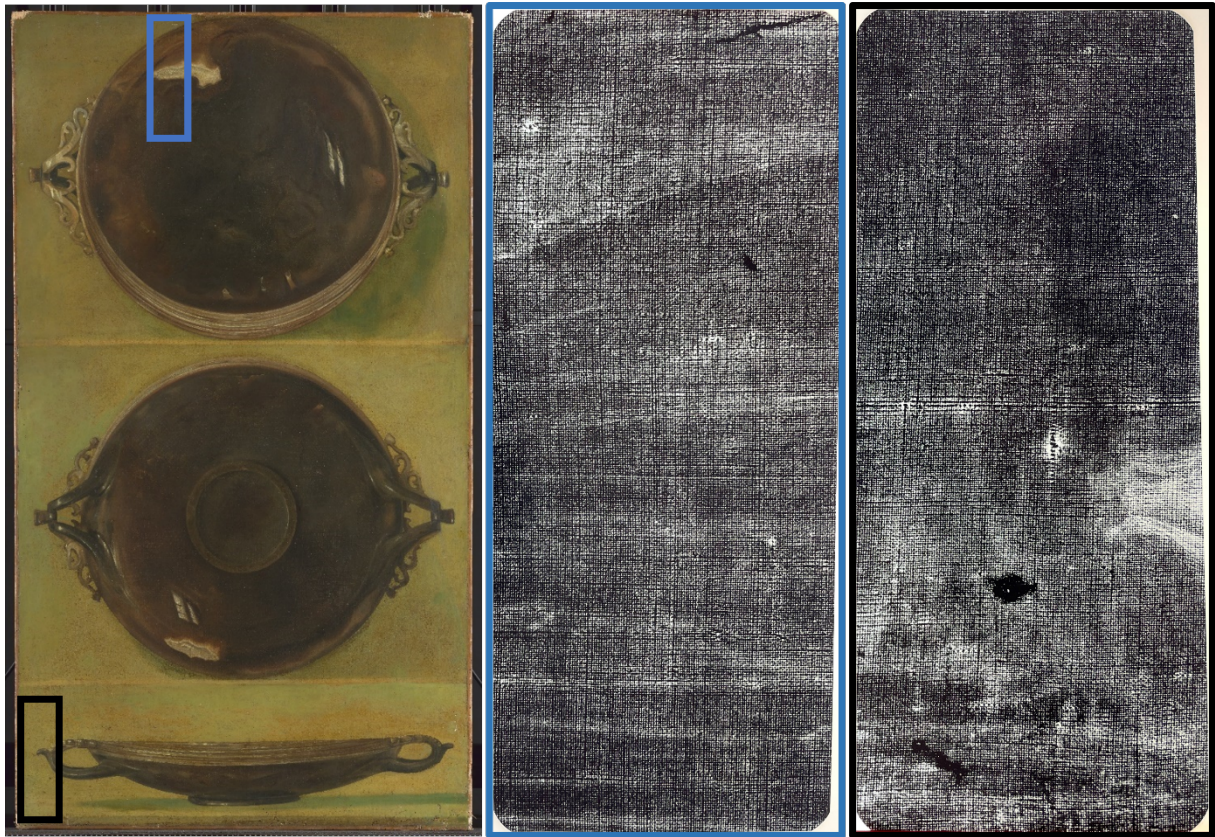
Image 5: X-radiography, showing the weave and condition of the original canvas.
