# THE MUSEUM OF MODERN ART

The David Booth Department of Conservation

**TITLE:** *Twin*

**ARTIST:** Robert Ryman

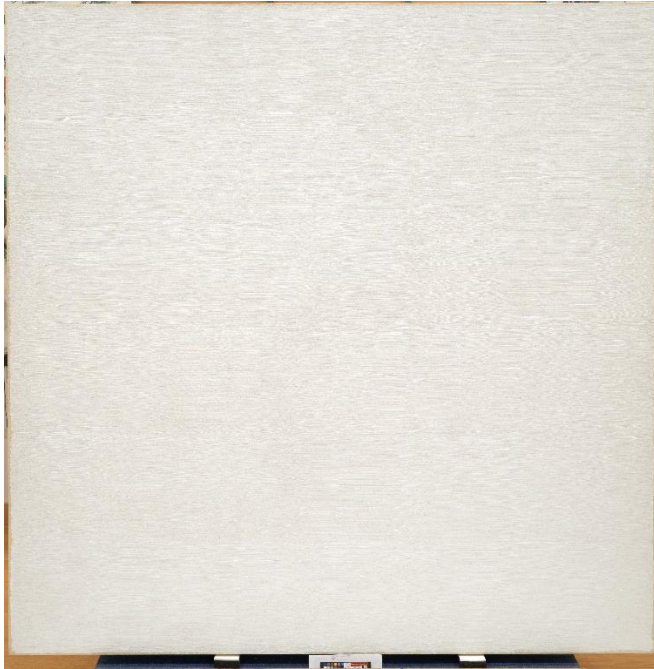
Normal Light:

**After Treatment:**

- 4) The dents were eased into plane using a combination of moisture and suction. A slightly dampened piece of blotter paper was held against the area for ~1 min. Then, a Mitka mini suction apparatus was placed against the canvas verso, and allowed to run for ~5 min. This process was repeated until the dents were no longer visible under normal illumination and barely noticeable in raking light (6 times total).
