The David Booth Department of Conservation

TITLE: Naxos

ARTIST: Jack Youngerman

DATE OF EXAMINATION: July 1, 2024

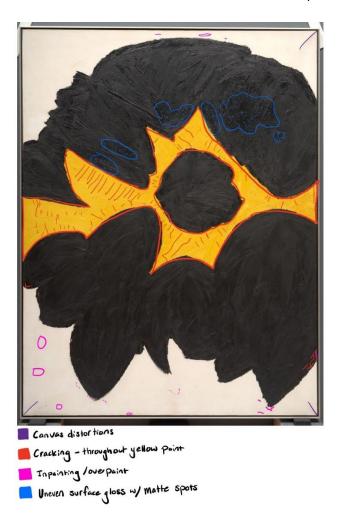
The yellow paint has an extensive craquelure pattern. These cracks generally appear stable. There is a small loss in the center left, as well as an area with mismatched retouching near the left edge of the central, black circle (see images below)

On the lowest, right edge of the black paint, there is an ~2 in loss along the turnover edge, as well as unstable, lifting cracks surrounding it.
